## Pre Purchase Building Report

| <b>Report No:</b> | SMI-270718 | | |
| <b>Inspection address:</b> | 1 Bob Street Johnson, VIC, 3299 | | |

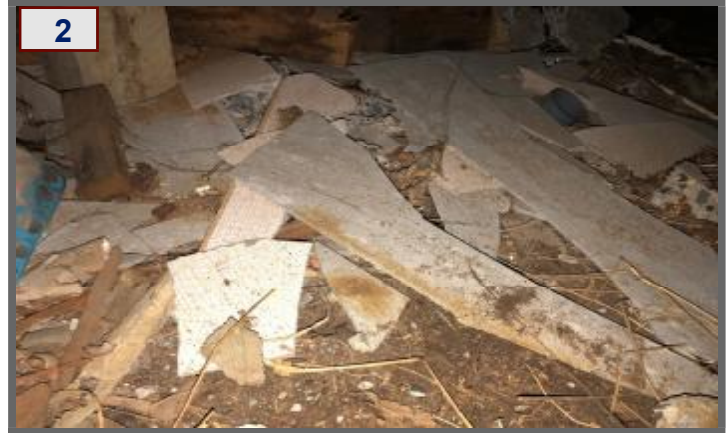
Cement Sheet Debris

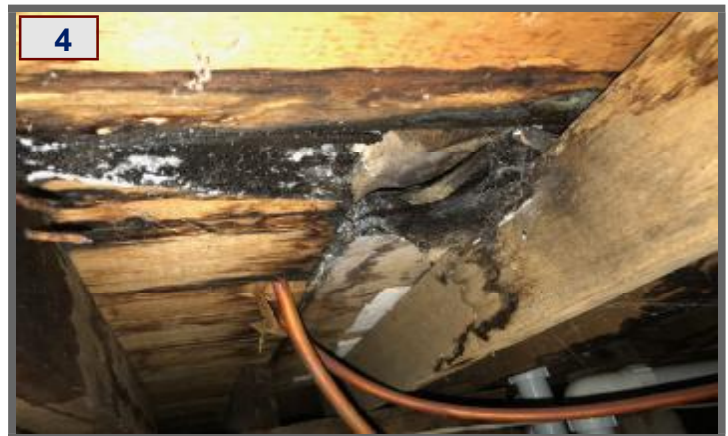
Floor Under Shower Damaged

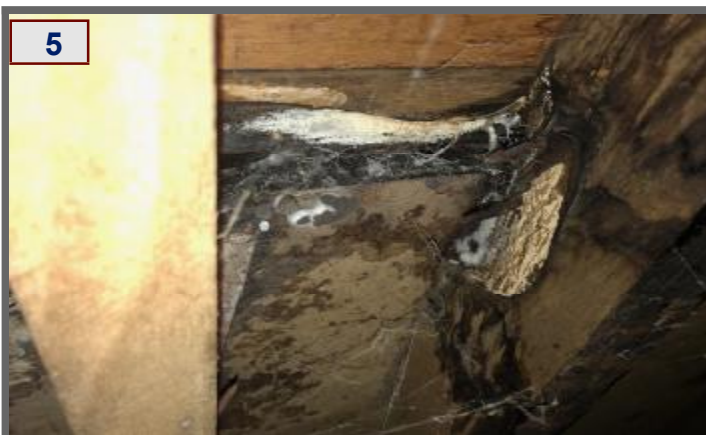
Floor Under Shower Damaged

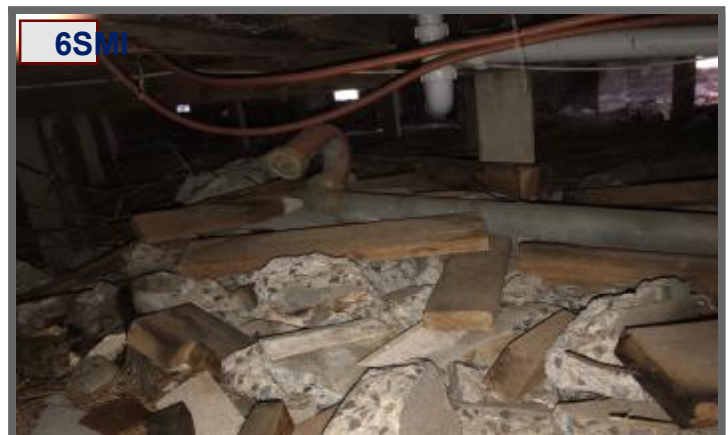
Debris Under Bathroom

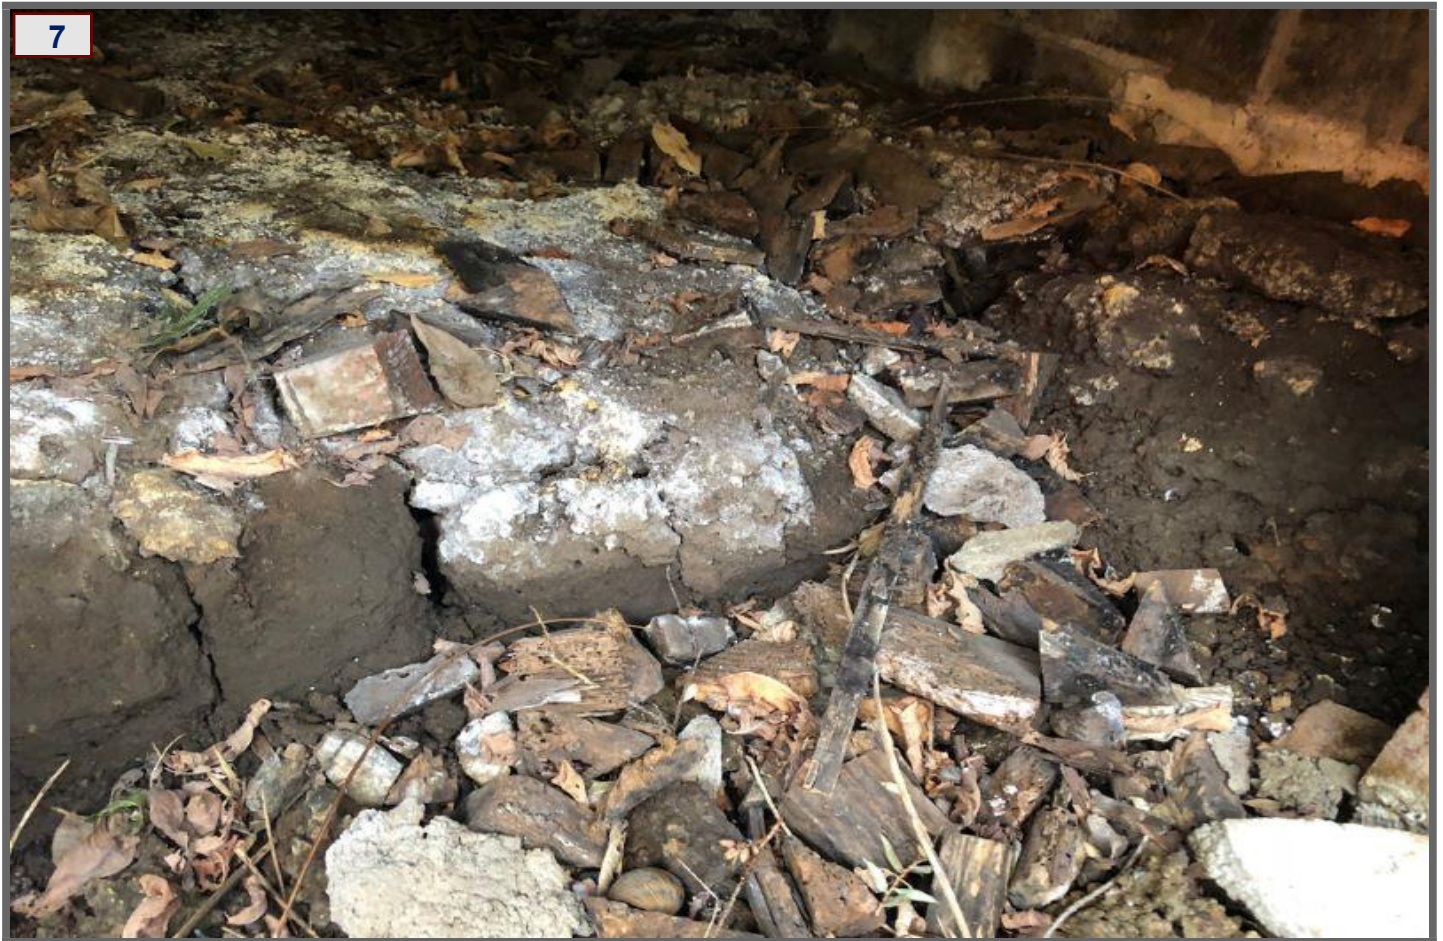
- ~ Sub Floor Structure: There is cut or missing structural components under the shower base. (1)(4)
- ~ Sub Floor Space: There is debris and rubbish in the sub floor space making access for inspection and maintenance difficult. Broken cement sheet was found under the bathroom discarded from renovating the shower. Because of the age of the property and the appearance of the material used in the lining it is advised to have an asbestos inspection carried out on the property. (2) (3) (4)
- ~ Stump Footings: Stumps have been packed to support bearers and packing is not of a suitable material or secured in place at several areas. (2)(6)
- ~ Sub Floor Structure: There is evidence of water damage to the flooring under the bathroom, this will require renovation of the bathroom to rectify. (2) (6)
- ~ Sub Floor Space: The ground in the sub floor space was wet at the South/ East corner. (2)(4)

Subfloor Wet

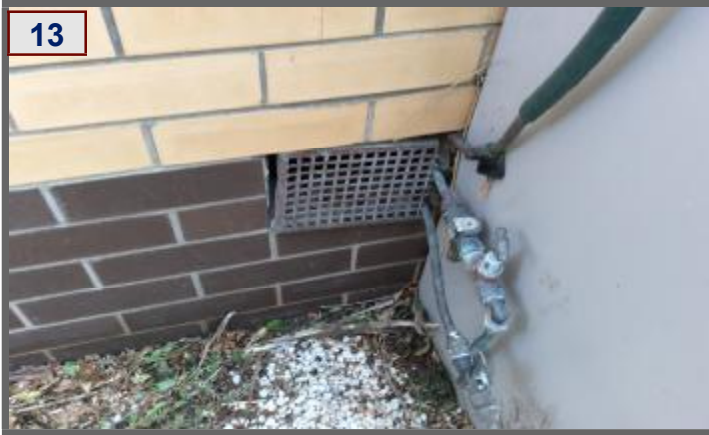
~ Brickwork: The brick vents are loose, this is most likely caused by poor installation methods. These allow air to circulate under the house and keep vermin out. (2) (6)

Brick Vent Loose

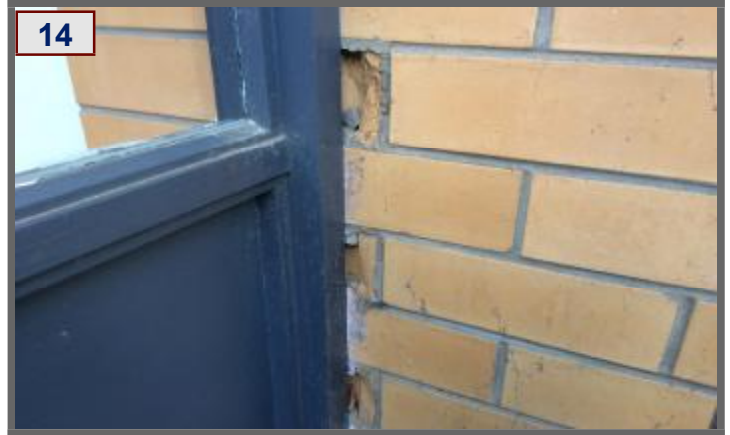
~ Brickwork: The brickwork was damaged most likely caused by removal of a previous structure at the rear porch area. (2) (6)

Bricks Damaged

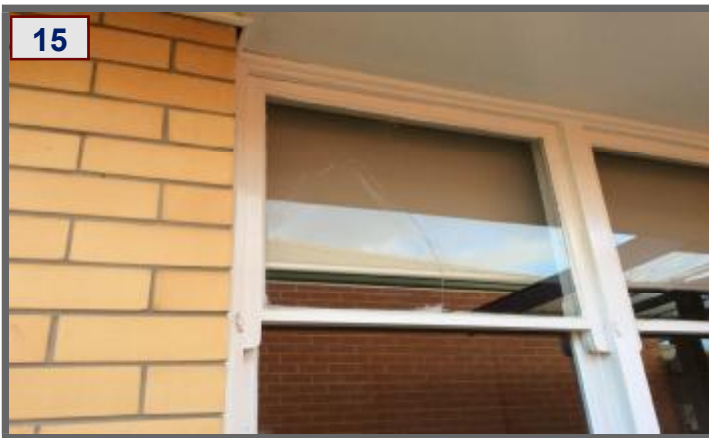
~ Timber Windows: Broken glass panel at Bed 2 and Kitchen windows. (2) (3) (6)

Glass Broken

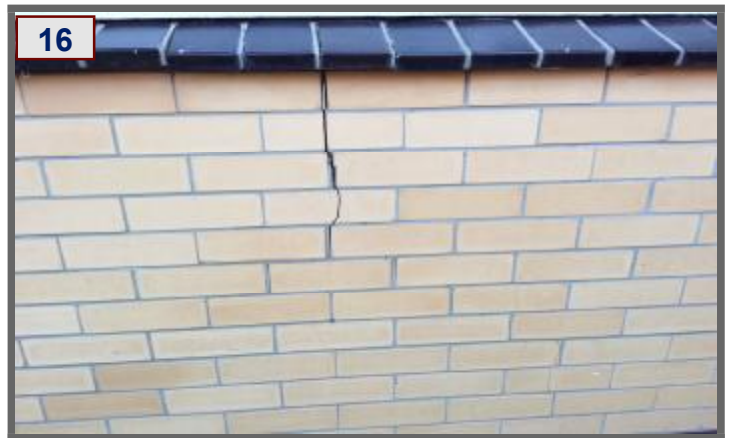
Brickwork: Major cracking of the brickwork usually associated with failure of the footings and movement in the foundations found at several areas. (1) (4)

Brick Walls Cracked

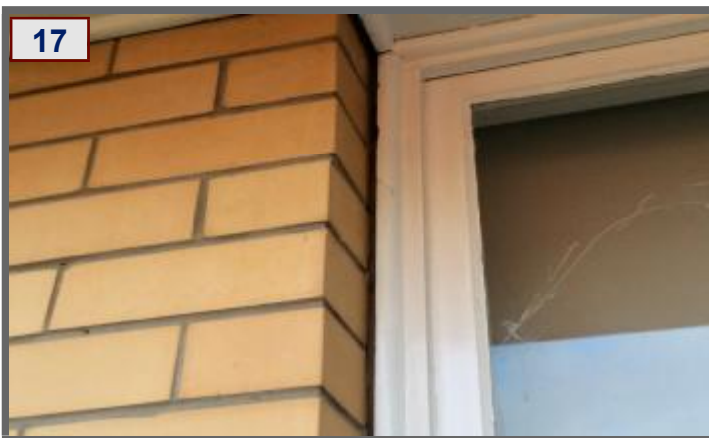
~ Brickwork: Displacement of the brickwork caused by significant movement of the wall or its footings was found at the West wall of the house and Front Entry. (1) (4)

Brick Walls Moved

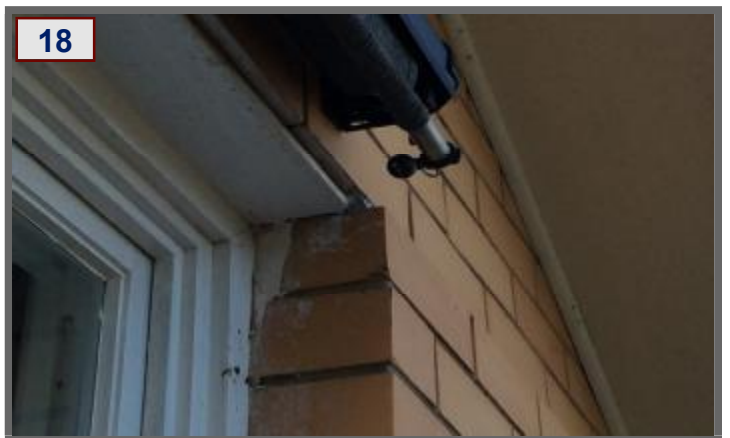
Brick Walls Moved

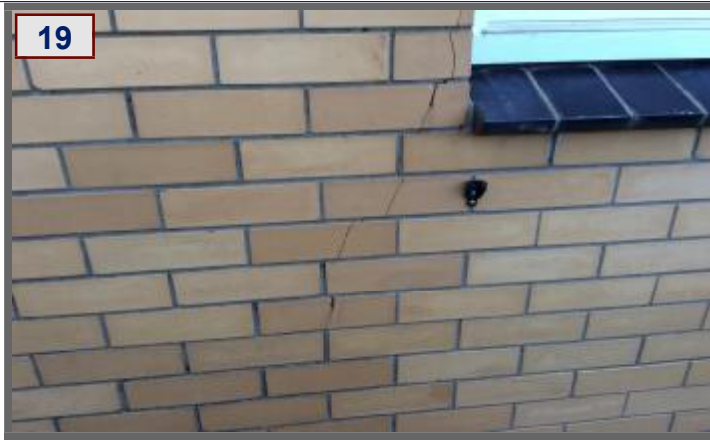
Brick Walls Cracked

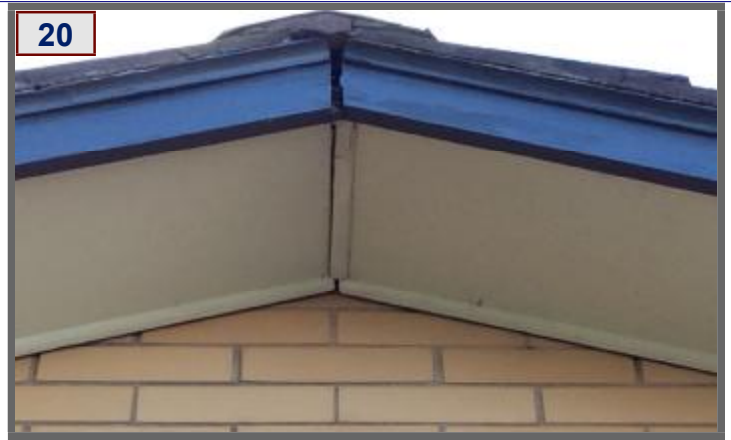
~ Fascia Boards: There has been movement at the gable joint most likely caused by movement of the brick wall and foundations on the west end. (2) (6)

Roof Structure Moved

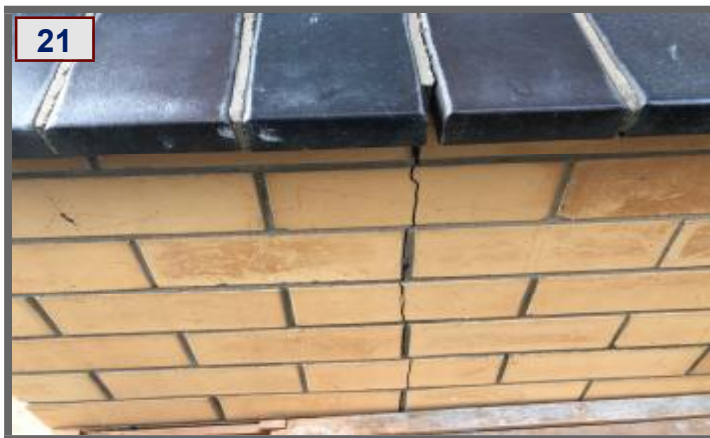
Brick Walls Cracked

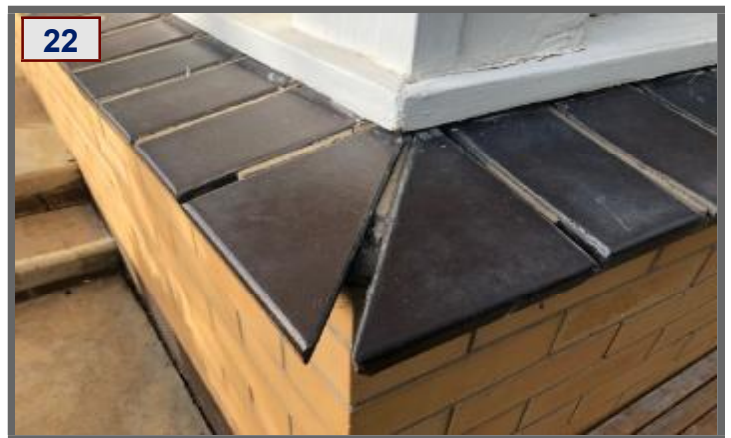
~ Brickwork: Tiled sills are damaged or loose at several areas. (2) (6)

Sill Tiles Moved

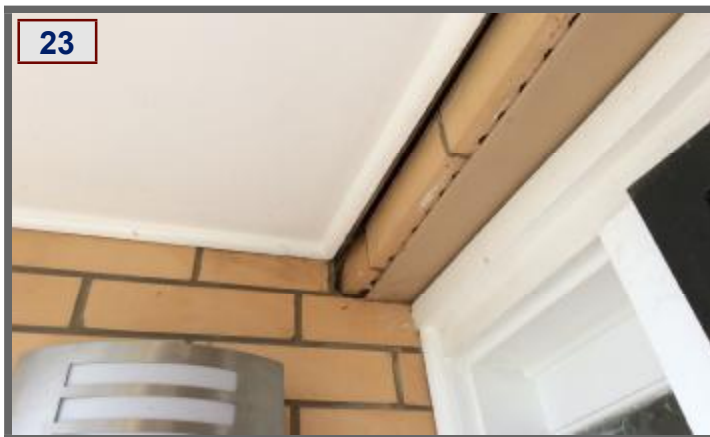
Brick Walls Moved

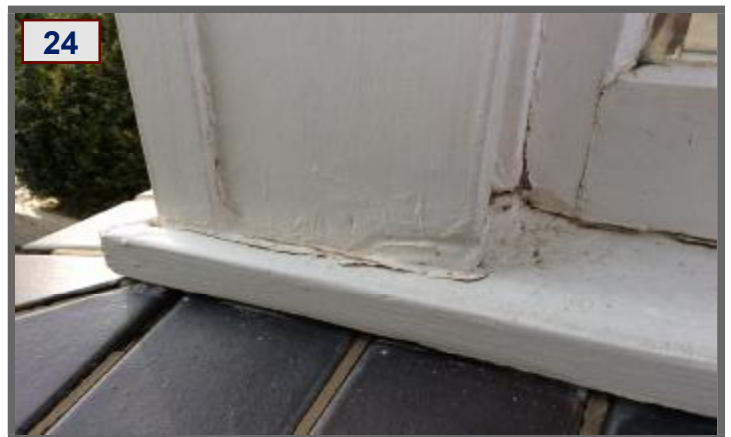
~ Timber Windows: Window frames are warped, split and decayed these will need repair or replacement to prevent further damage to other elements of the building at some areas. (2) (6)

Windows Decayed And Repaired

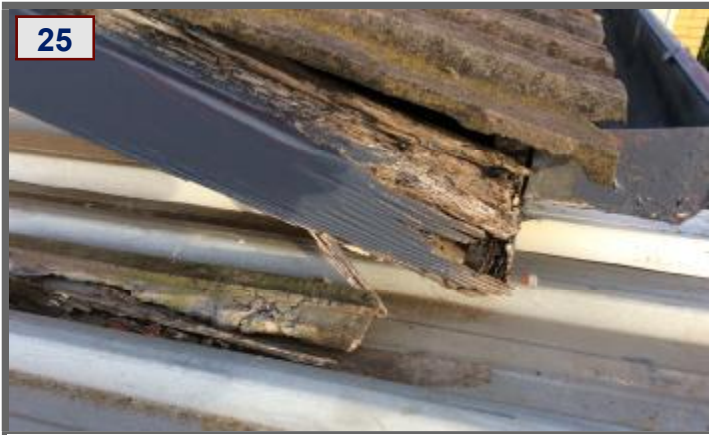
~ Fascia Boards: Fascia boards are decayed and will require repairs or replacement to prevent decay spreading to other structural elements at several areas. (2) (6)

Fascia Boards Decayed

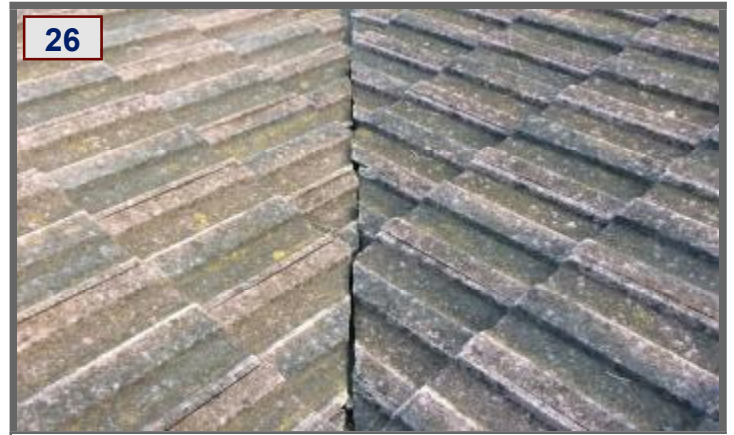
- ~ Gables & Trims: The timber trim is warped, split and decaying at several areas. (2) (6)
- ~ Main Tiled Roof: The valley tiles have been cut so that they meet tight together. Although this was a method used when the home was built it is no longer used. There is no access to inspect the metal gutter below for damage and it causes debris to build up restricting the flow of water. (2) (6)
- ~ Gutters: Debris, rubbish etc built up in several areas of the guttering need removing to provide proper flow to the outlets. (2) (6)
- ~ Main Tiled Roof: Cracked pointing to the hip and ridge capping in several areas leaves the capping tiles unsecured to the rest of the roof surface. (2) (6)
- ~ Verandah Roof: There is no guttering installed on the verandah roof an indication that it may not be certified or compliant. (2) (4)

Valleys Cut Tight

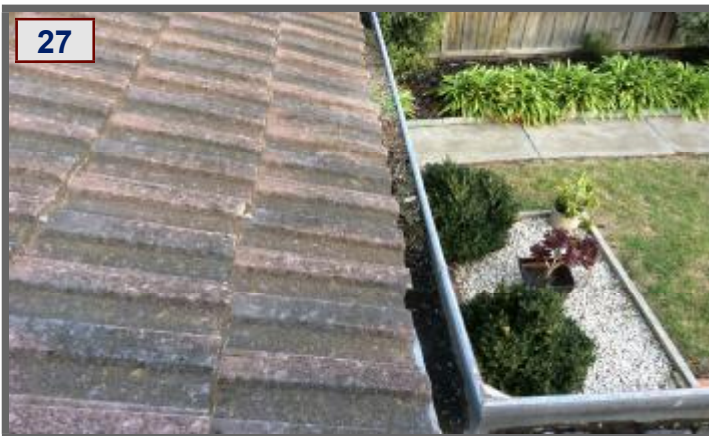
Debris In Gutters

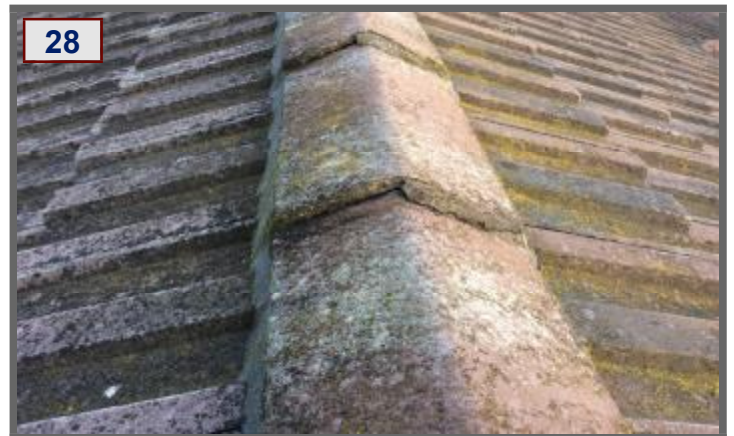
Tile Pointing Cracked

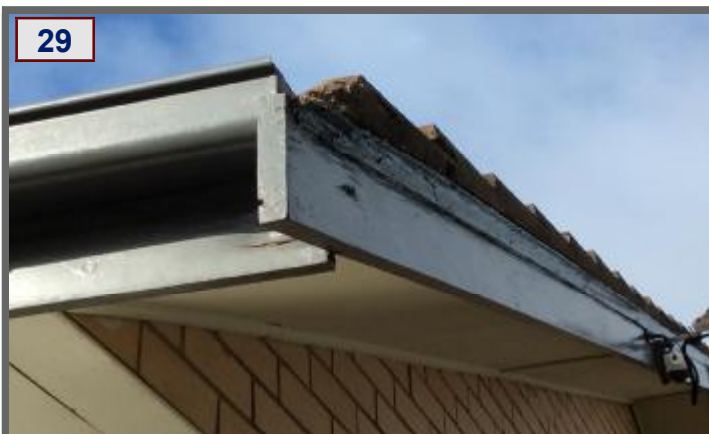
Fascia Boards Decayed

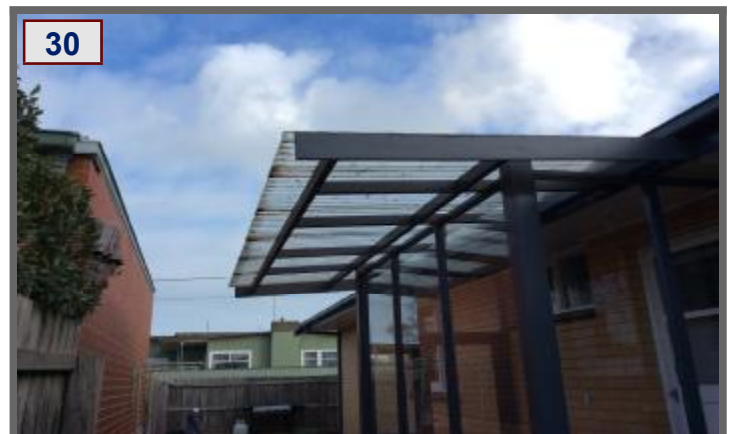
No Gutter On Verandah

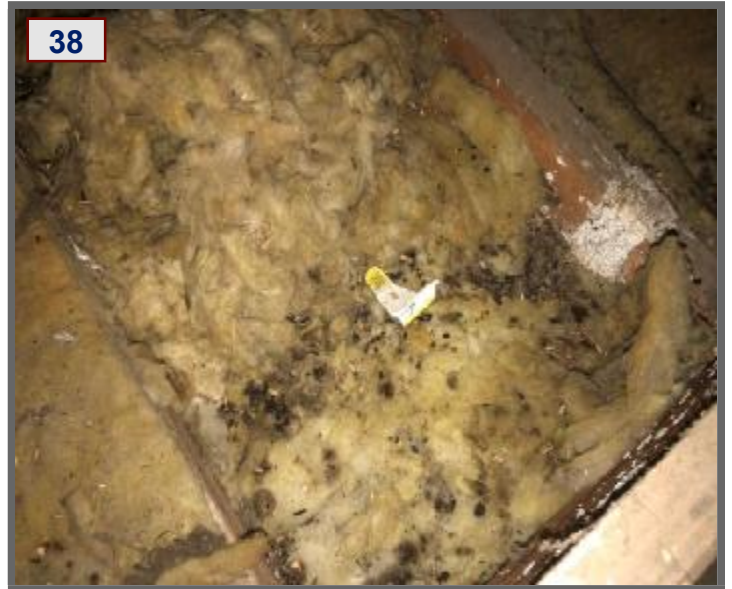
Evidence Of Rodents

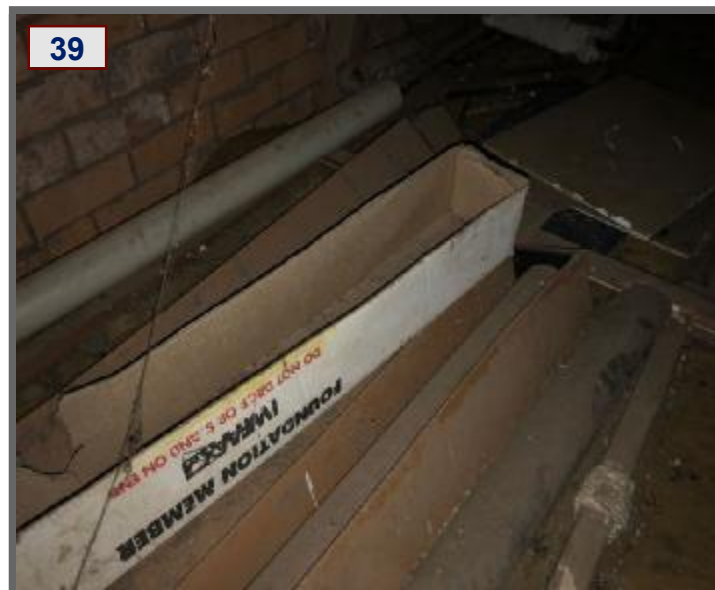
Debris On Ceiling

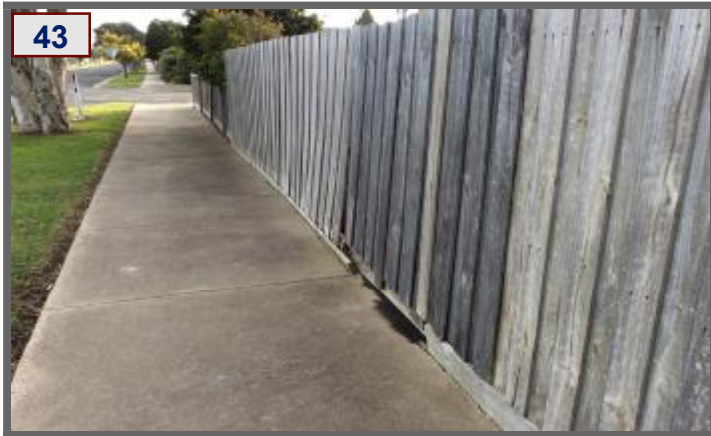
- ~ Fence: The fence is leaning over and unstable at several areas. (2) (6)
- ~ Fence: The fences have broken, loose and deteriorated components at several areas and may require replacement. (2) (6)

Fences Deteriorated

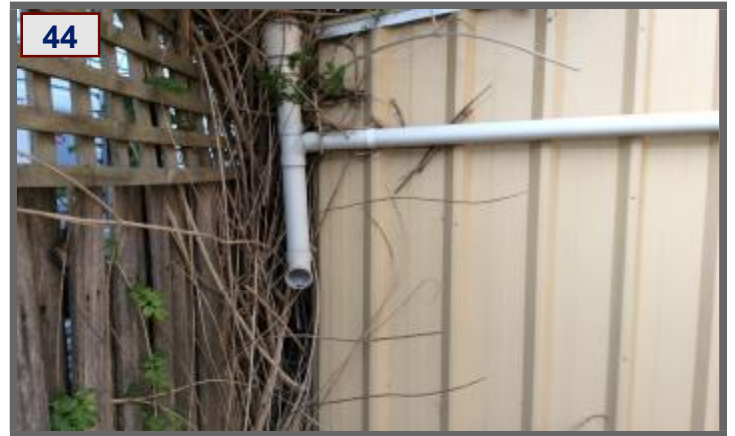
- ~ Garden Shed: The storm water pipes on the shed are not connected and are discharging onto the ground causing erosion around the shed. (2) (6)
- ~ Building Site: Garden beds against the house encourages watering in dry weather which can cause damage to the footings and surrounding surfaces as well as significantly altering moisture levels in the ground. (2) (4)

No Storm Water Connected On Shed

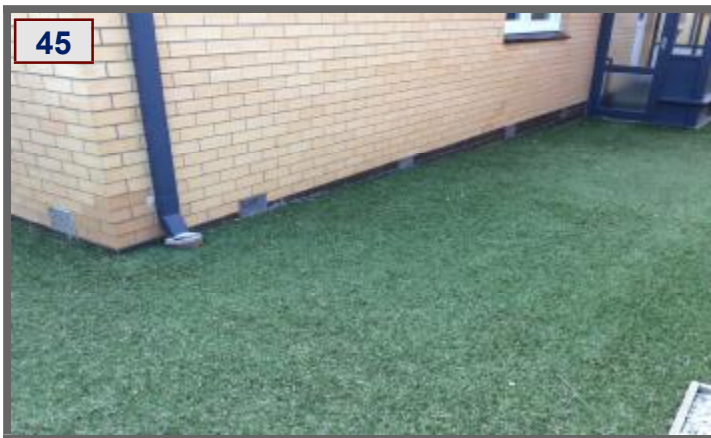
No Surface Drainage Installed

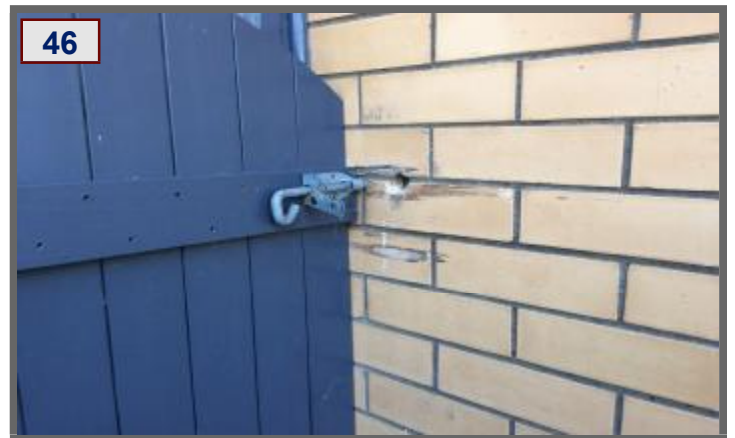
Gate Out Of Alignment

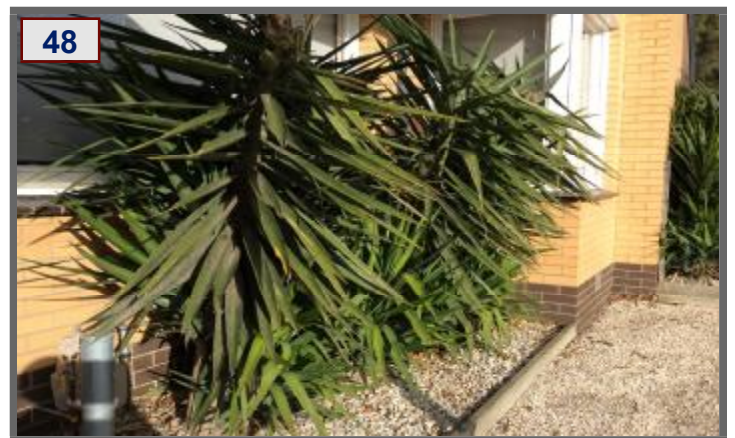
Gardens Against House

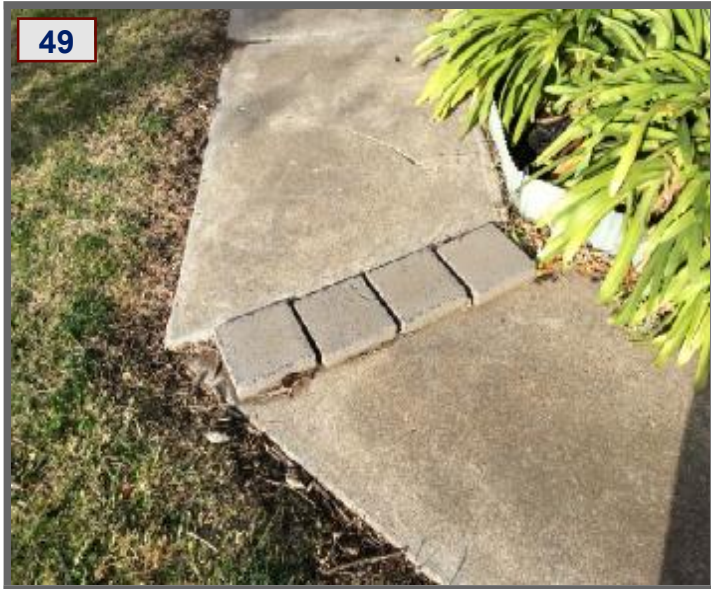
- ~ Concrete Footpaths: The footpath was found to have significant displacement in some areas causing a trip hazard and indicating a lack or failure of reinforcing mesh. (2) (6)

Paths Cracked And Displaced

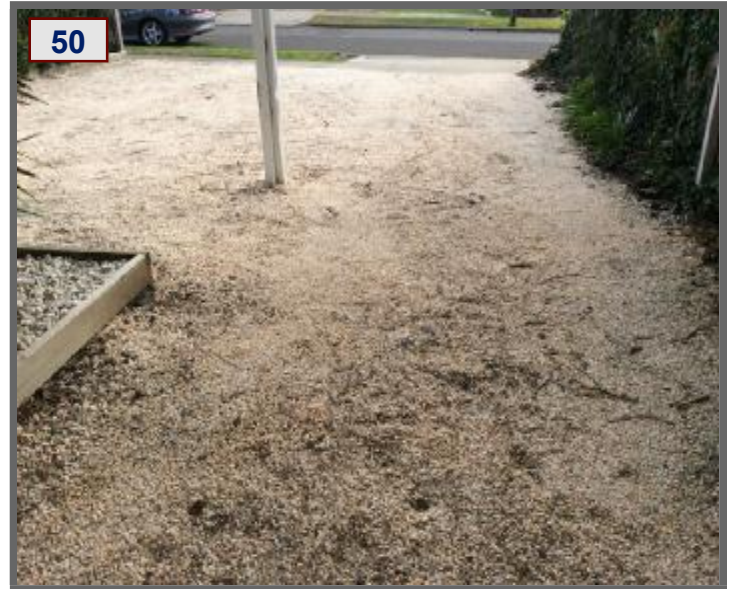
- ~ Gravel Driveway: The driveway has loose laid gravel which cannot be compacted and is not suitable for the purpose. (FYI)

Ungraded Gravel Drive

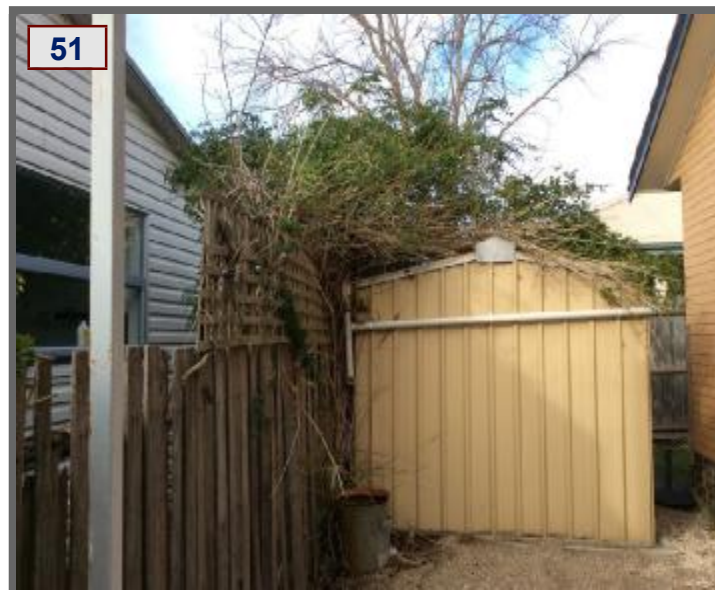
- ~ Building Site: Vegetation is overgrown in several areas making access difficult for maintenance and repairs as well as potentially causing damage. This vegetation may be growing on the adjoining property. (2) (6)

Over Grown Vegetation

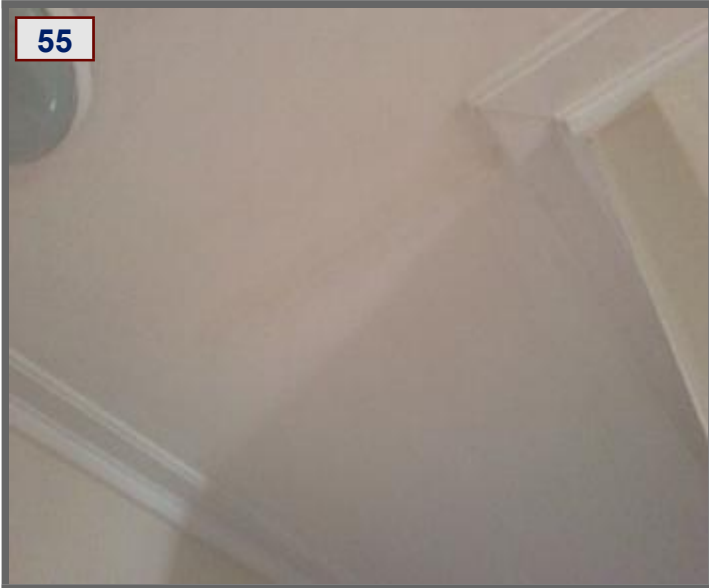
Cracked Plaster Ceilings

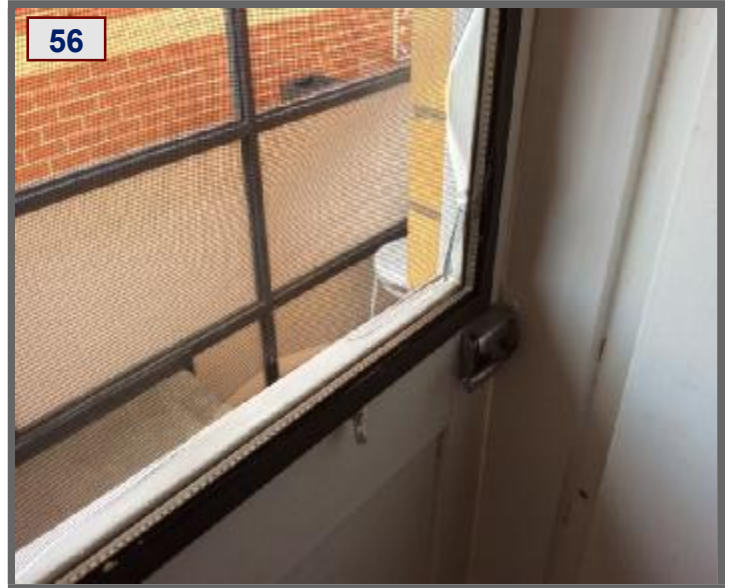
Damaged Insect Screens

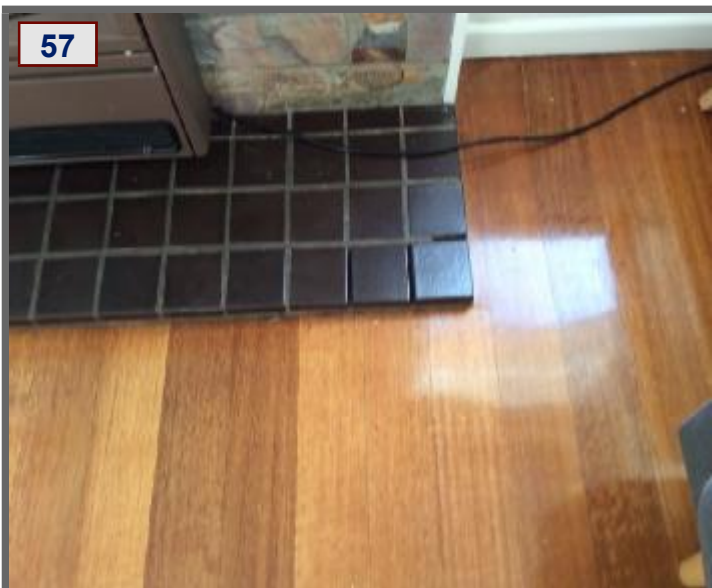
Damaged Tiled Hearth

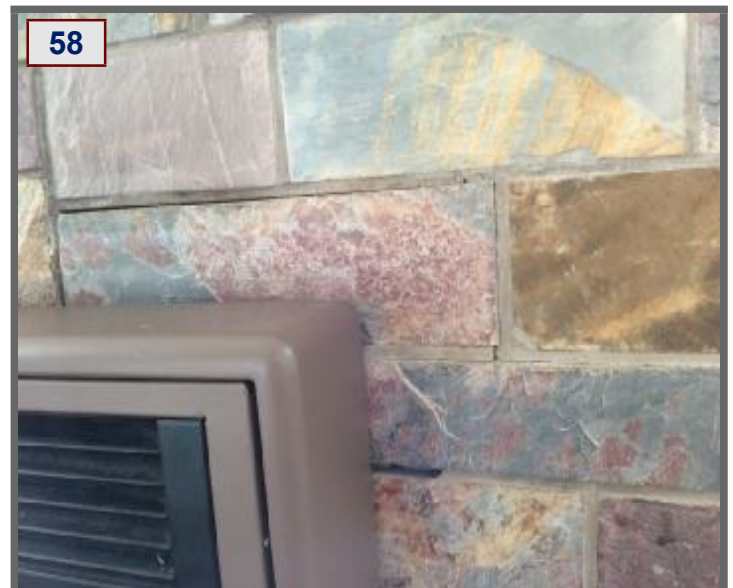
Cracked Tile Mantle

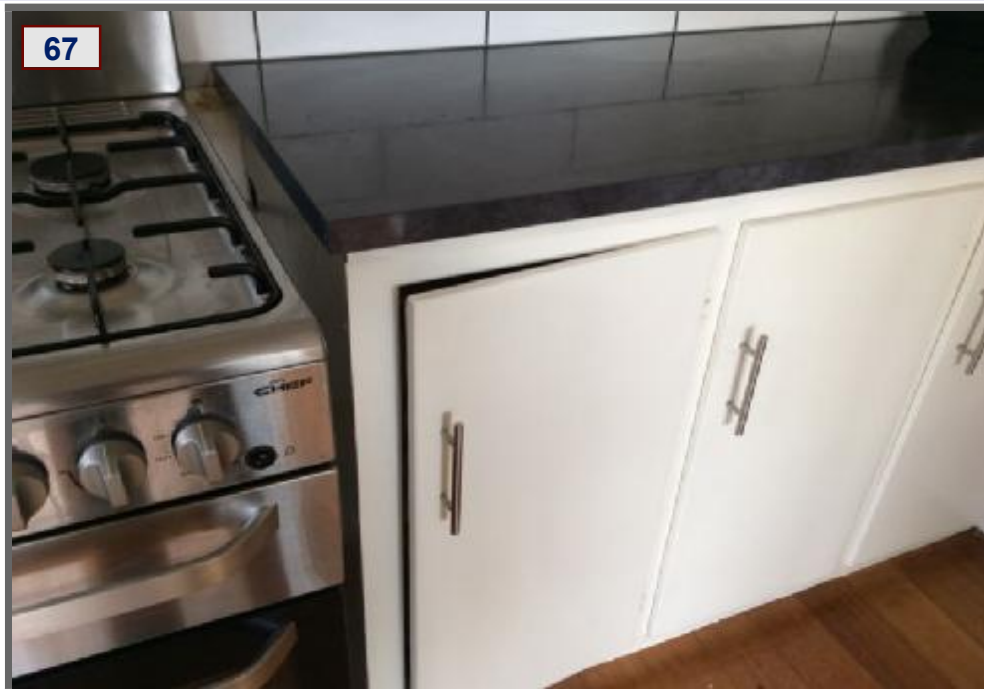
Doors And Drawers Out Of Alignment

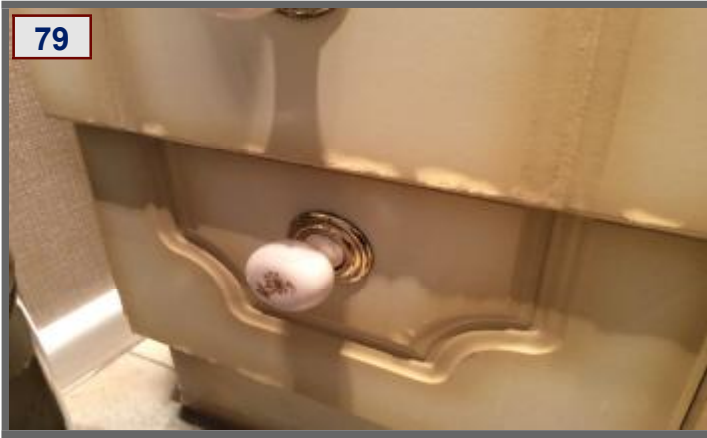
Water Damaged Vanity

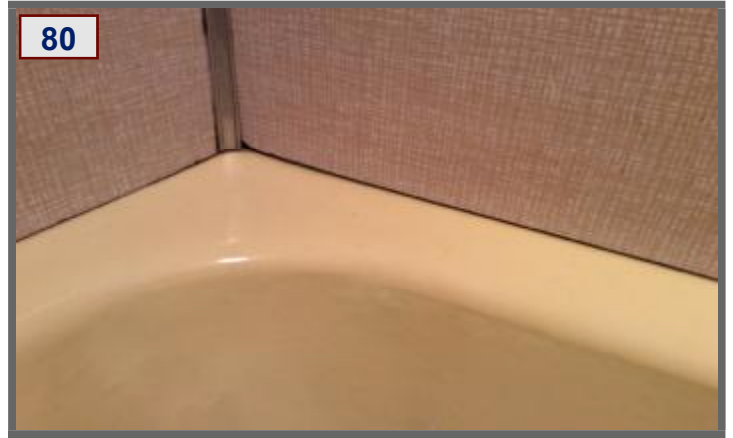
Sealant Around Bath

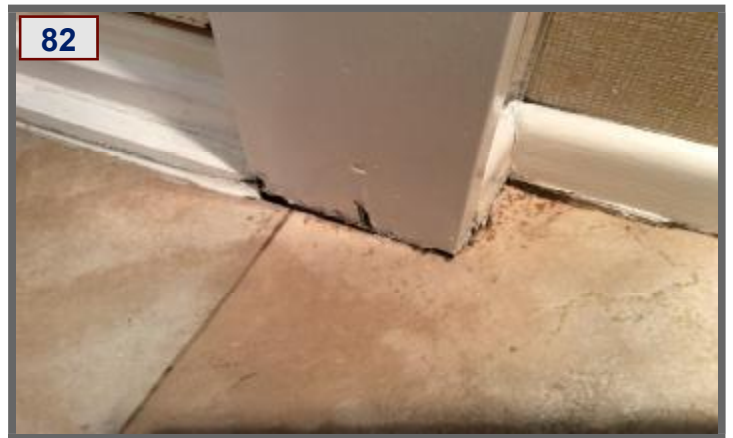
Leaking Shower And Decayed Timber

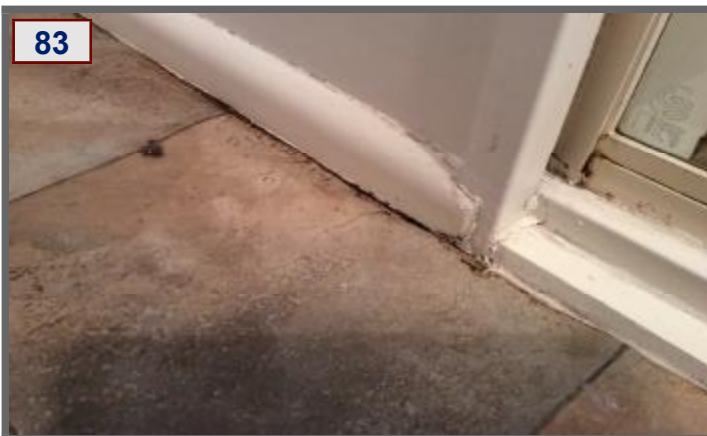
Decayed Skirting And Floor

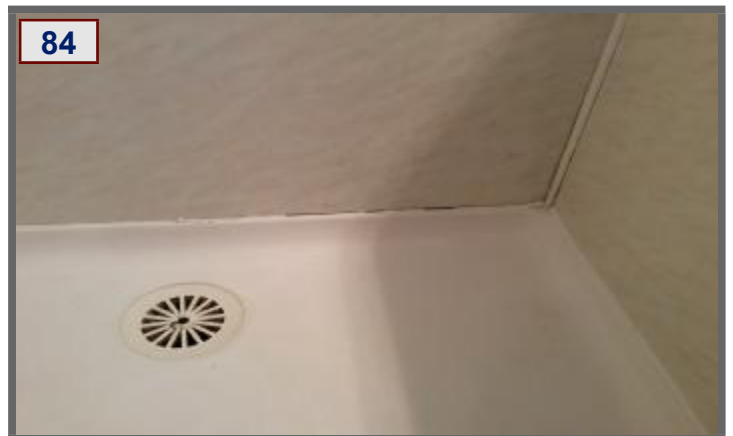
Sealant In Shower

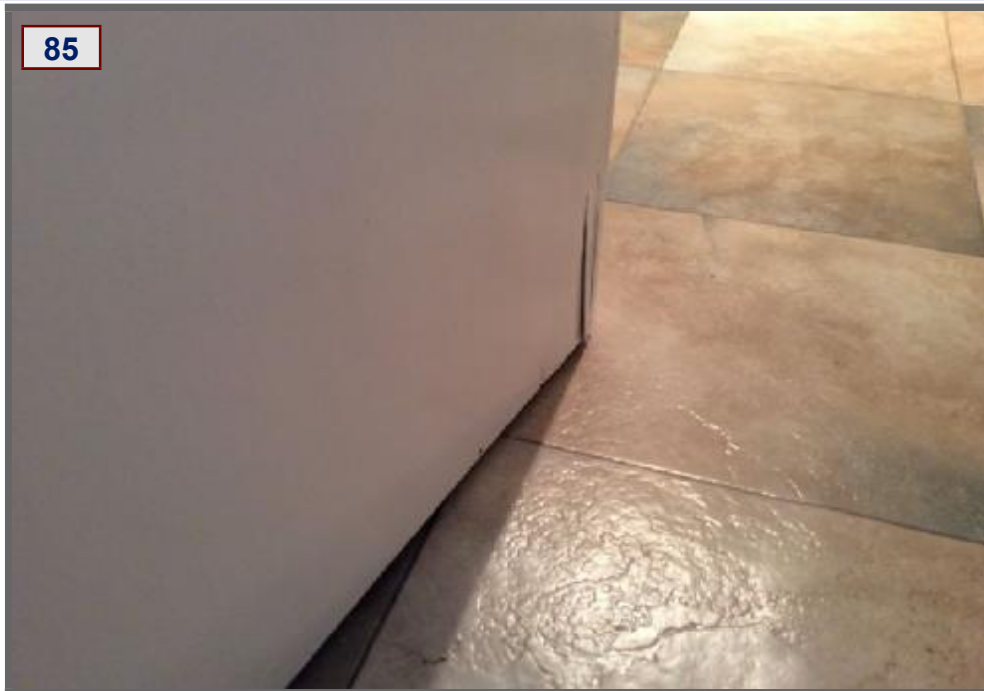
Door Damaged

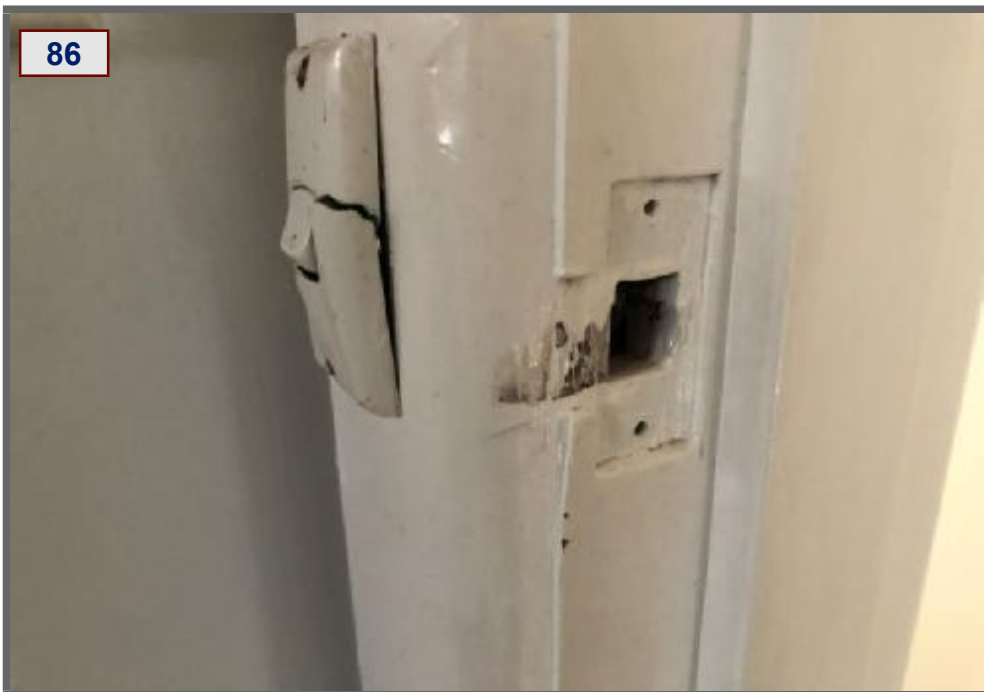
Door Strike Missing

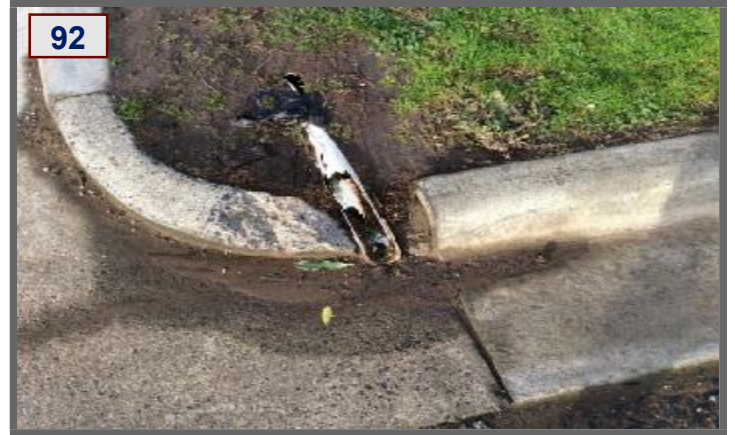
Storm Water Pipe Damaged

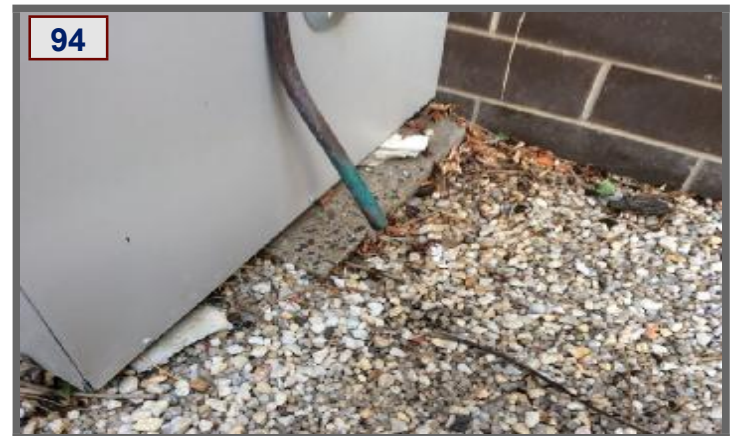
HWS Overflow Onto Ground

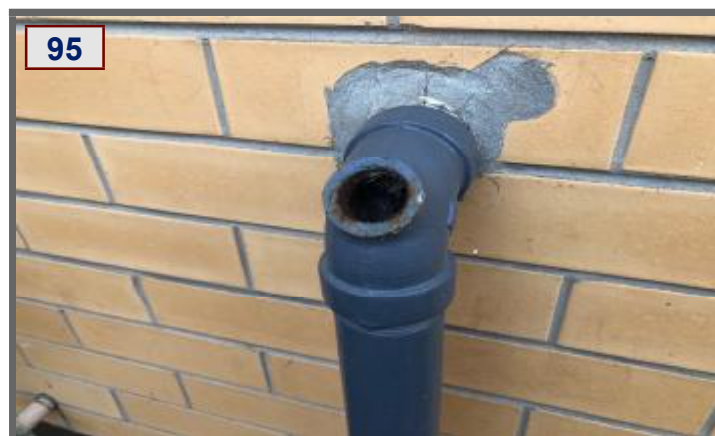
No Cap On Laundry Waste

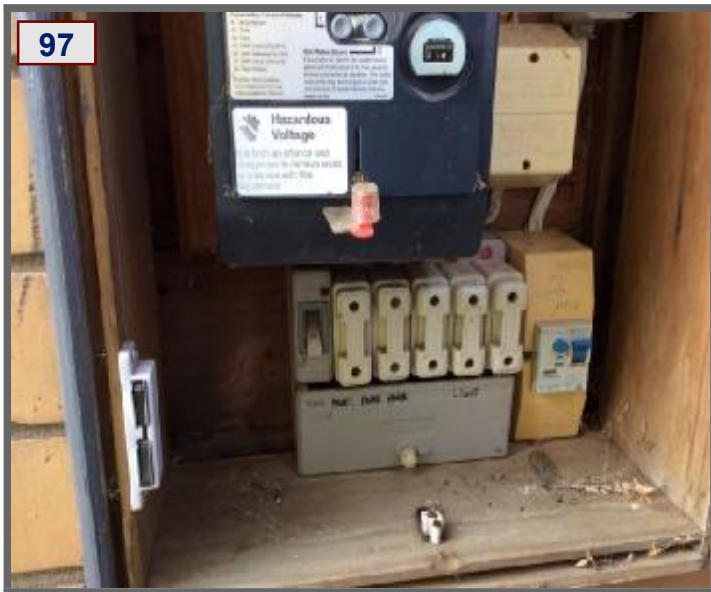
Ceramic Fuses

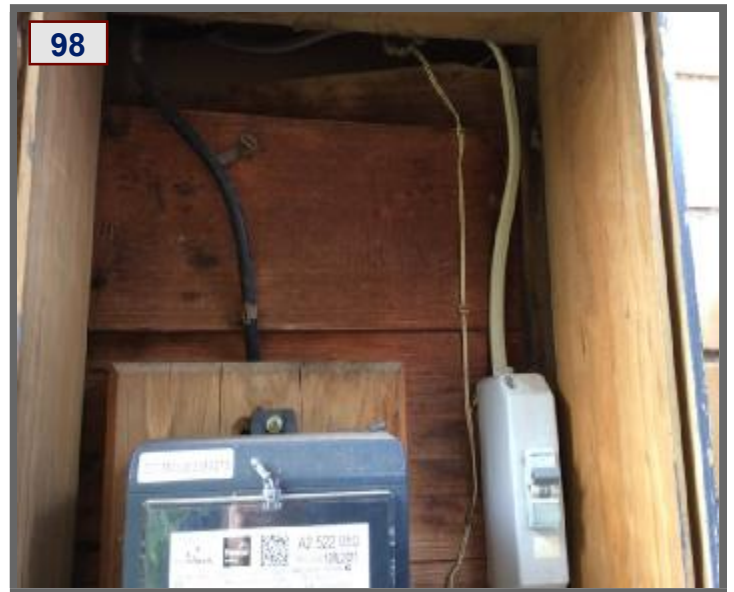
Meter Box Damaged

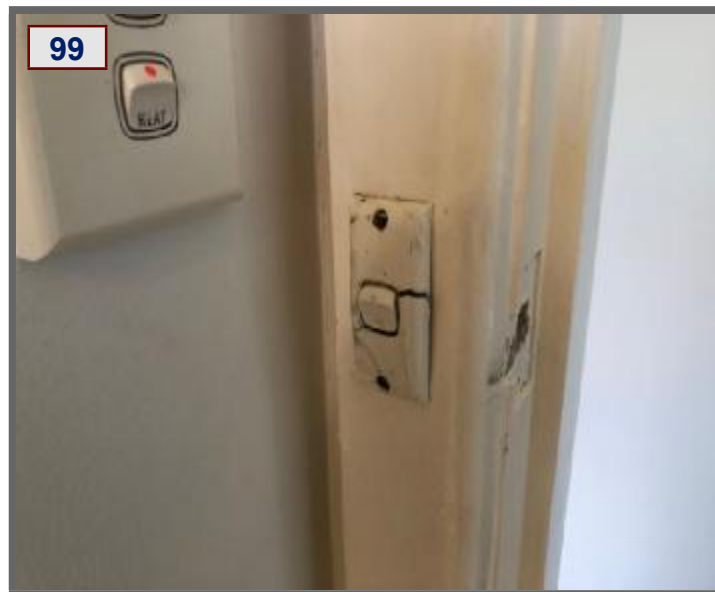
Light Switch Damaged

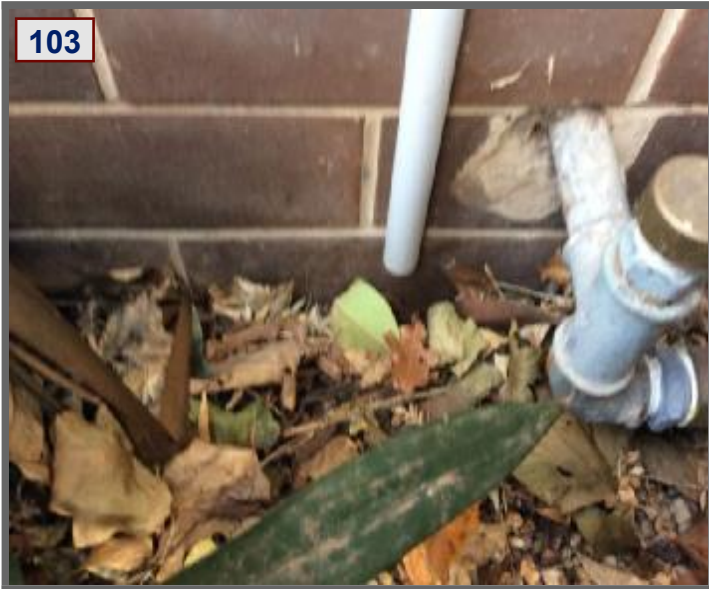
Condensation Drain Onto Ground

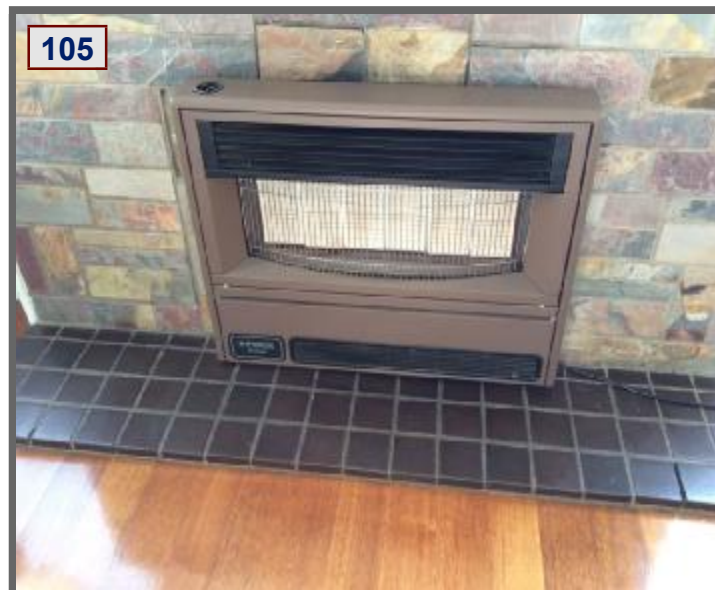
Vulcan Heater Disconnected

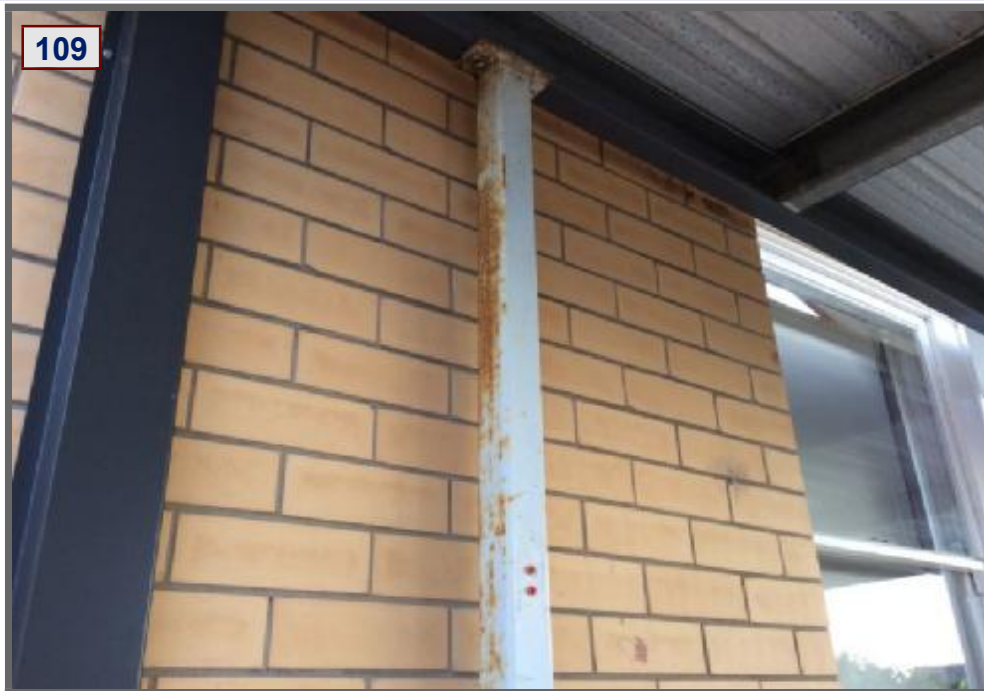
Posts Corroded

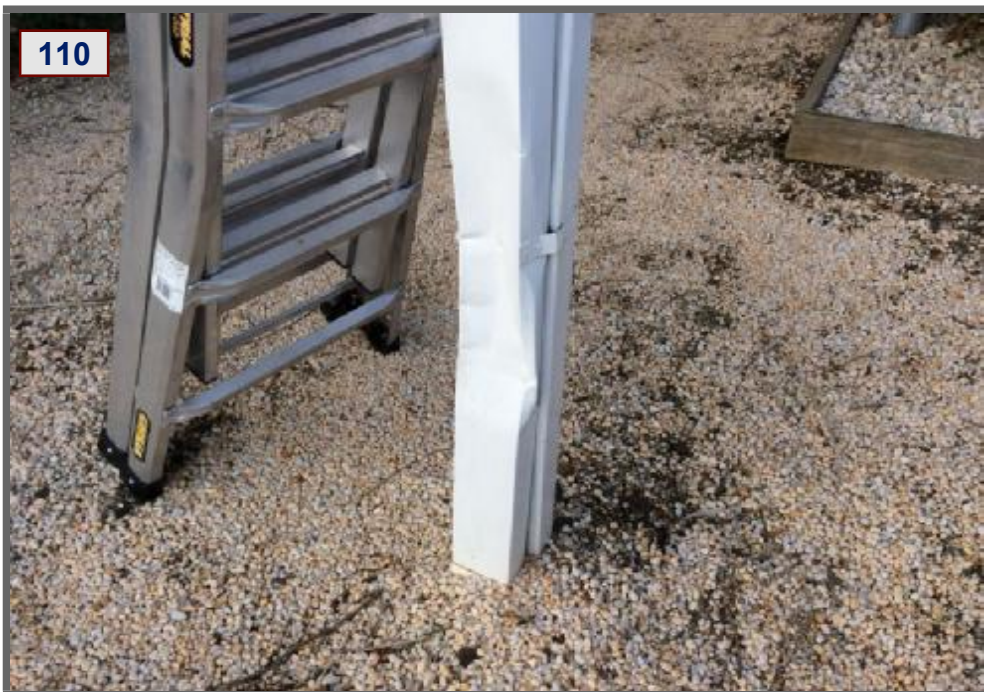
Down Pipe Damaged
