## Pre Purchase Building Report

| <b>Report No:</b> | SMI-270718 | | |
| <b>Inspection address:</b> | 1 Bob Street Johnson, VIC, 3299 | | |

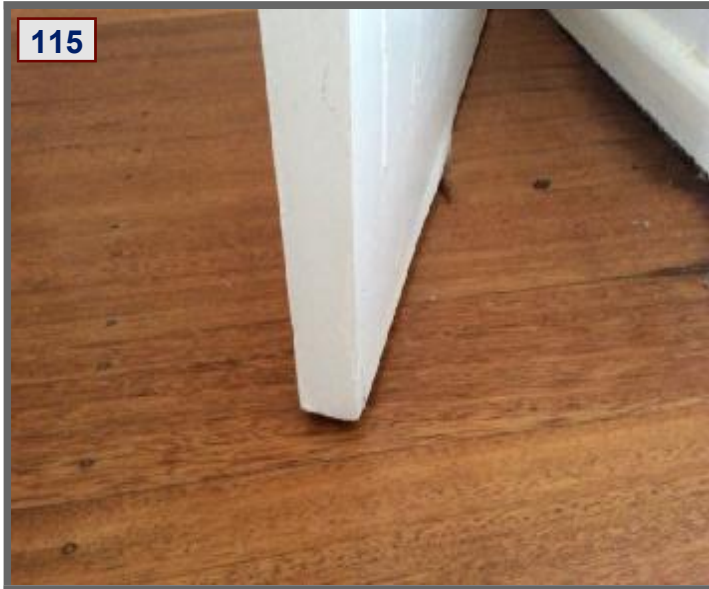
Door Damaged

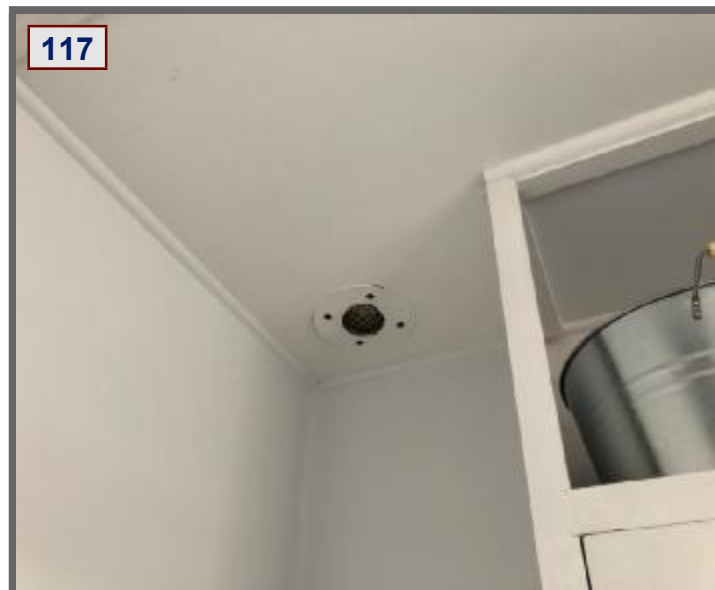
Hole From Previous HWS

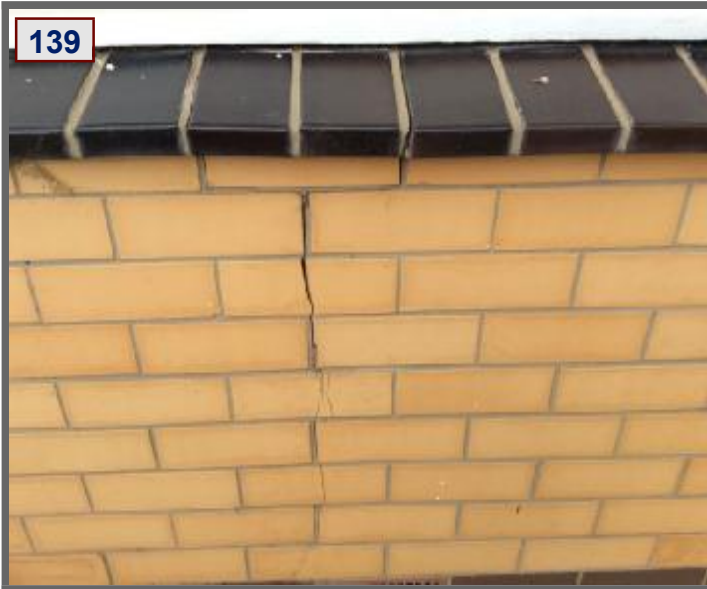
Cracked Brick Walls In Several Locations

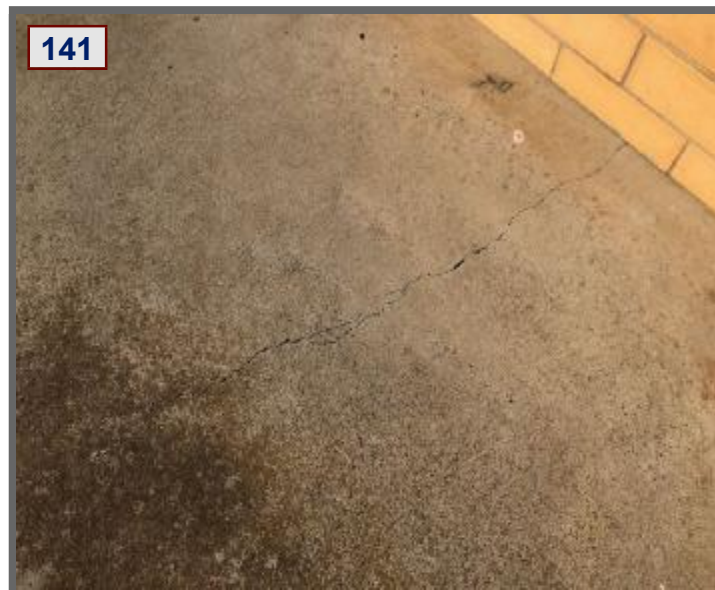
Cracked Concrete Paths And Balcony
