## Pre Purchase Building Report

| <b>Report No:</b> | SMI-270718 | | |
| <b>Inspection address:</b> | 1 Bob Street Johnson, VIC, 3299 | | |

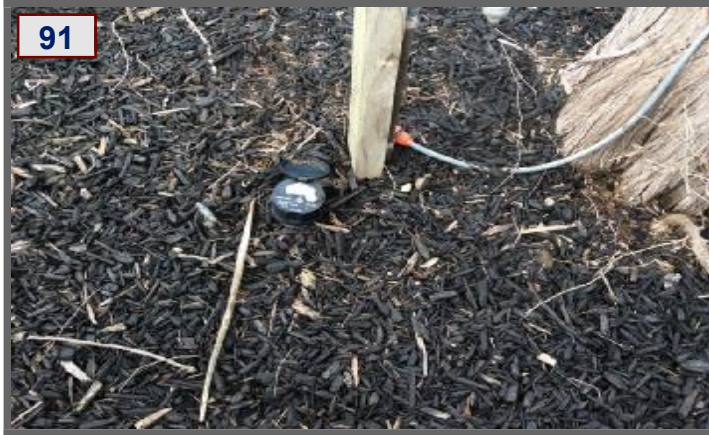
Water Meter Buried

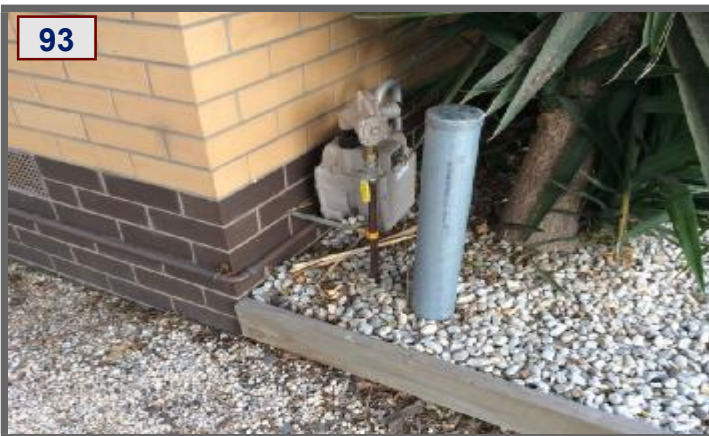
Gas Meter Location

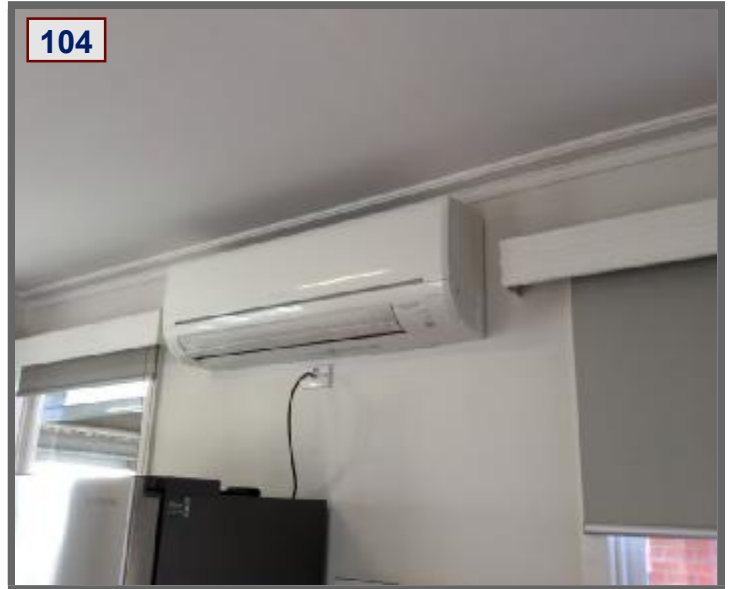
Split System Air Conditioner
