## Pre Purchase Building Report

| <b>Report No:</b> | SMI-270718 | | |
| <b>Inspection address:</b> | 1 Bob Street Johnson, VIC, 3299 | | |

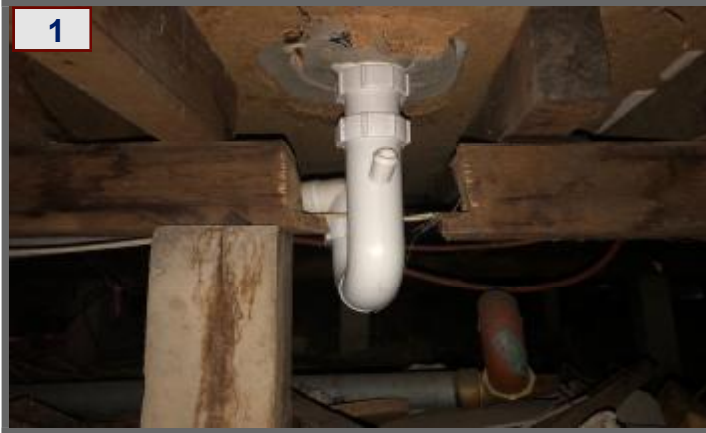
Structural Bearer Cut

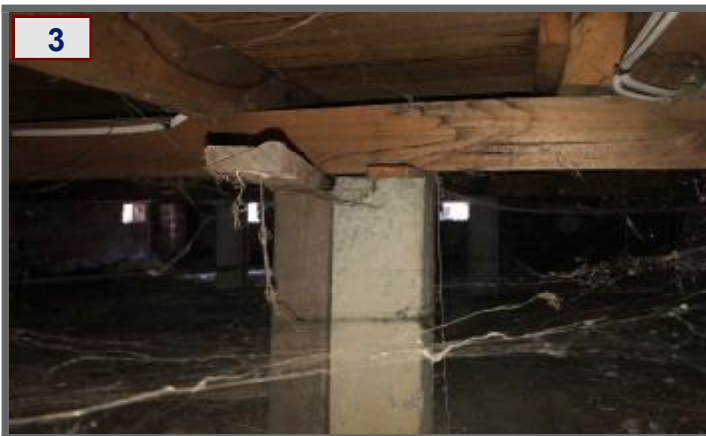
Stumps Packed

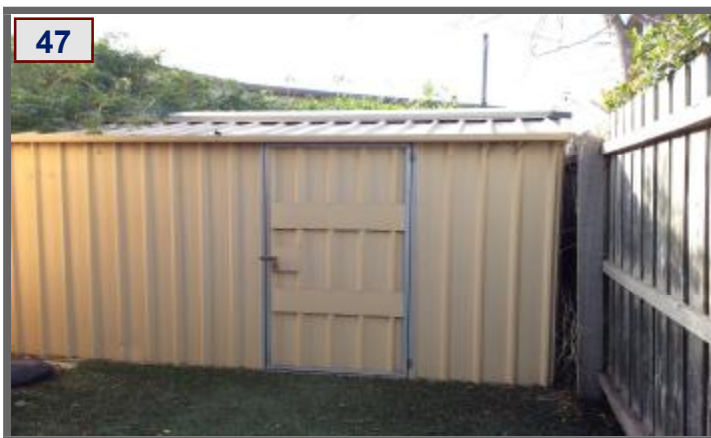
Garden Shed Size

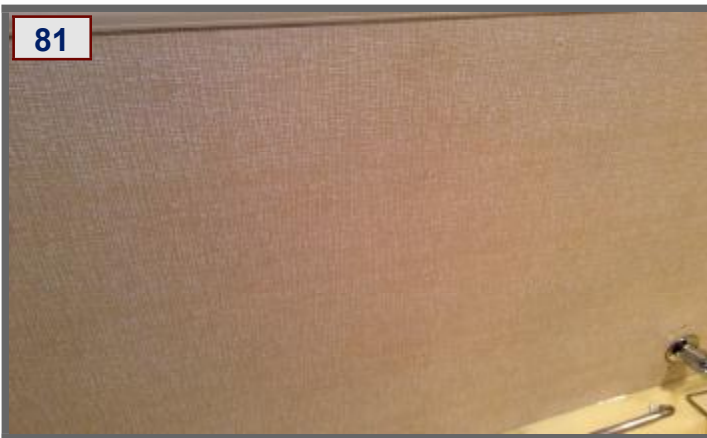
Cement Sheet Paneling

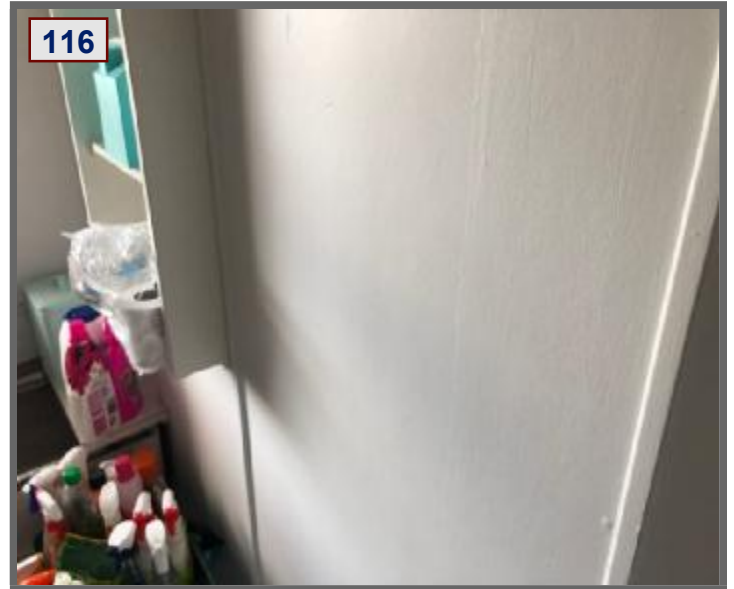
Cement Sheet Lining

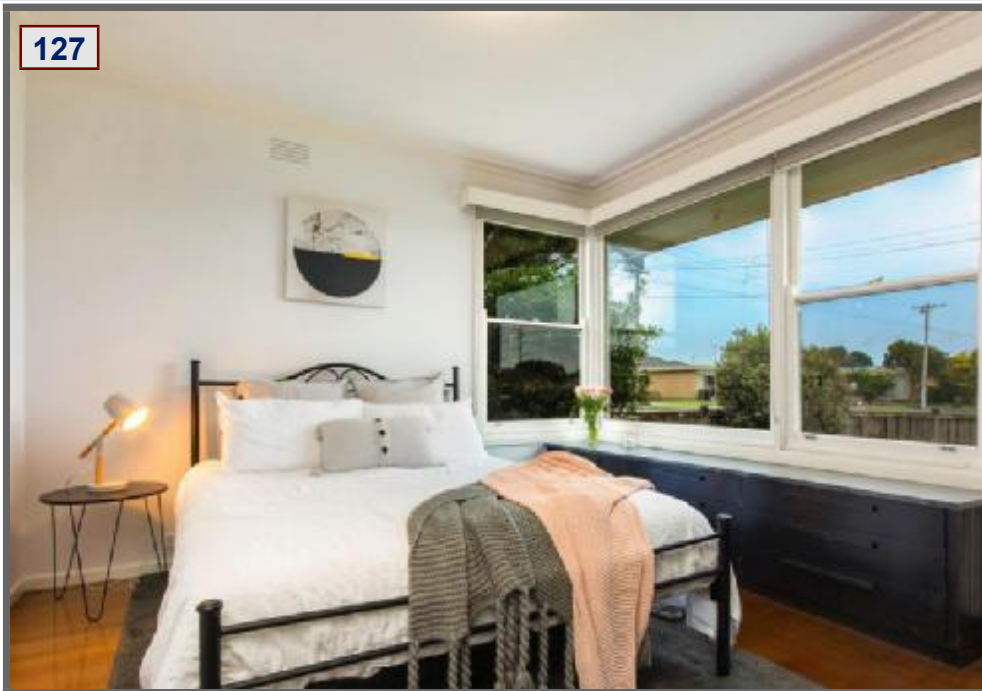
Home Fully Furnished

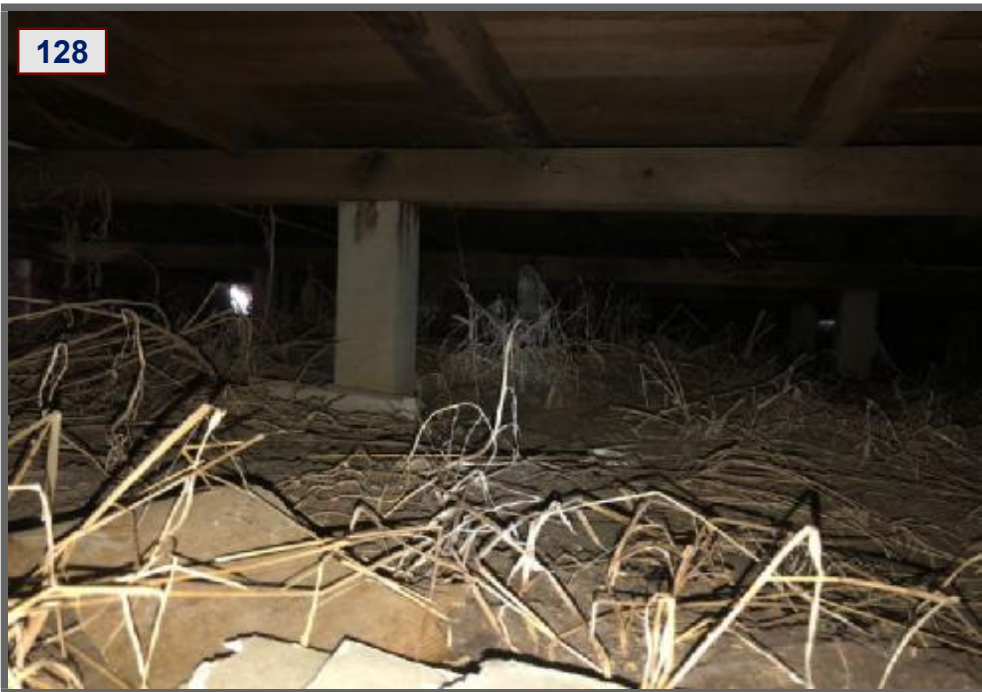
Low Areas Of Sub Floor
